**COMPREHENSIVE MONITORING REPORT NO. 1**

For the period May 8, 1997 to May 8, 2001

**POINT AU FER ISLAND HYDROLOGIC  
RESTORATION  
TE-22 (PTE22-24)**

**Second Priority List Hydrologic Restoration Project  
of the Coastal Wetlands Planning, Protection, and Restoration Act  
(Public Law 101-646)**

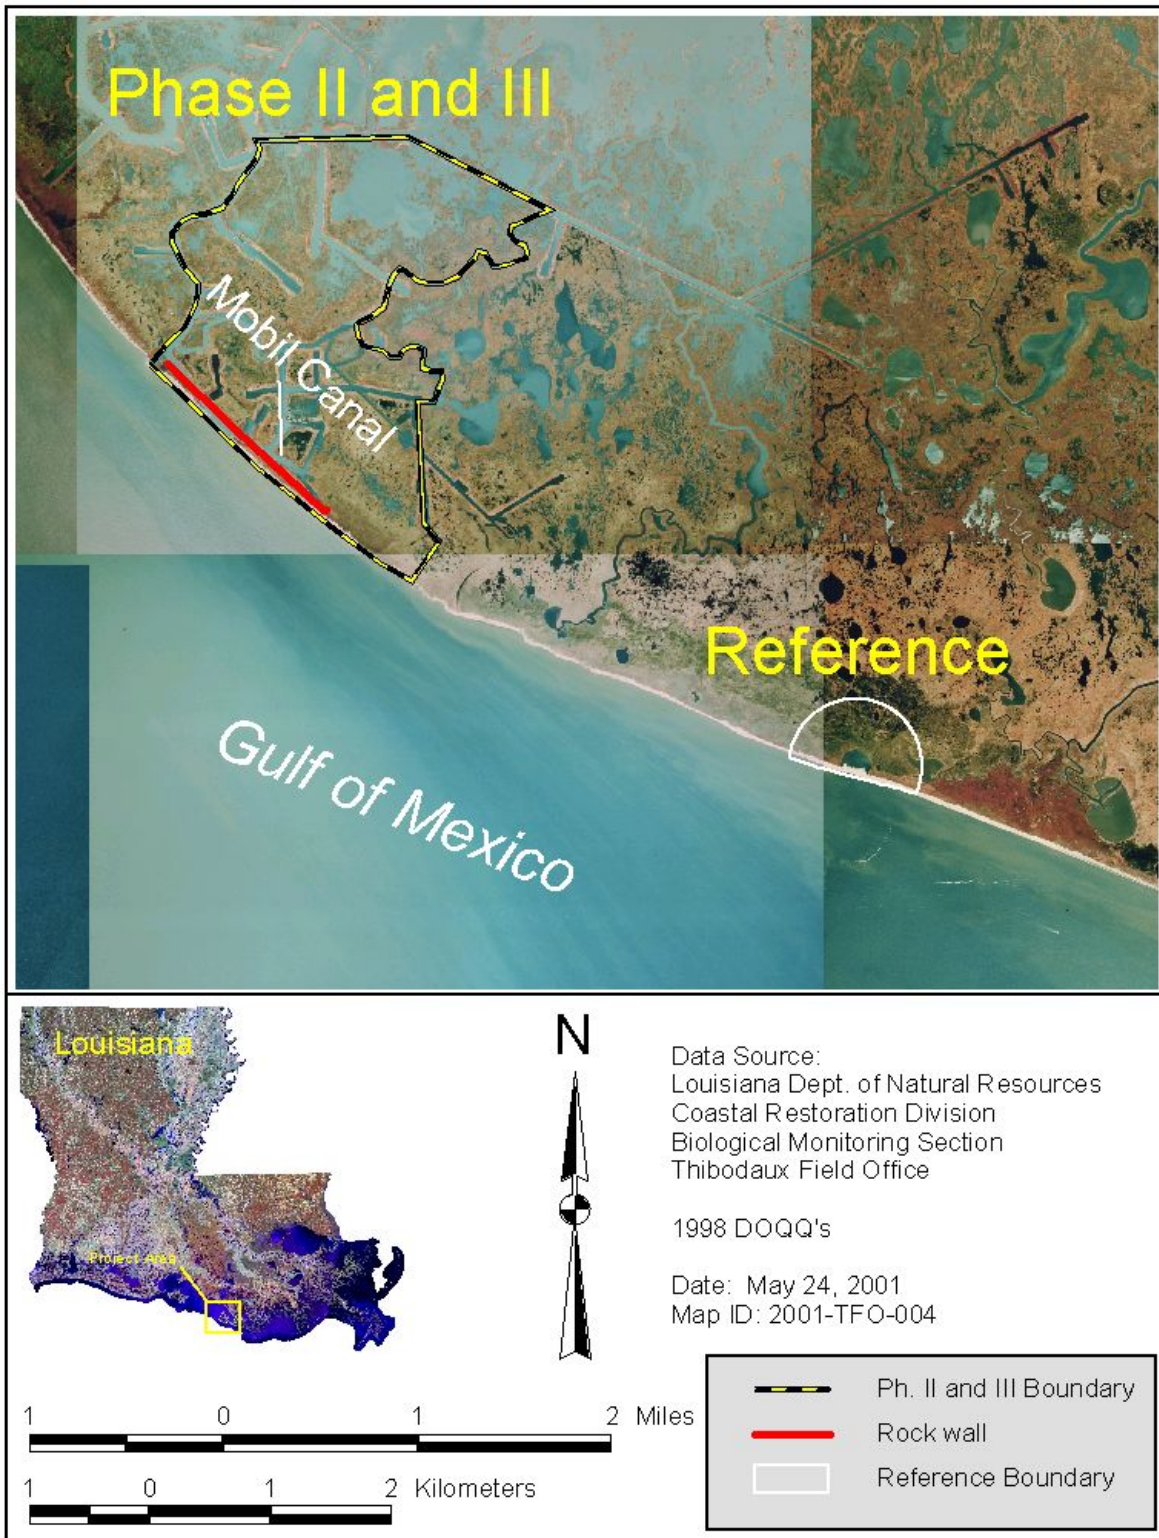
**Figure 3.** Point Au Fer Island Hydrologic Restoration (TE-22) project - Phase II and III boundary and features, and reference area boundary.

Phase II - The original intent of this phase was to backfill the oil well access canal known as Mobil Canal (figure 3). It was determined to be not economically feasible, therefore, the project was changed to a shoreline protection system (figure 6). In a joint financial effort between the LDNR/CRD, the NMFS, and the Mobil Oil and Exploration Company, approximately 3,600 ft (1,097 m) of 200 pound (90.72 kilogram) class stone underlain with a combination of geo-textile grid, filter cloth, and geo-textile woven fabric were constructed in the Spring of 1997. Construction was completed on May 7, 1997. The structure ranges from 25 ft to 33 ft (7.62 to 10.05 m) wide with an average height of 2.67 ft (0.81 m). There is a section of the shoreline referred to as the “breach area” - located near the eastern edge of the Phase II rock armor (figure 7). Within this area, the stone width was increased to a range of 35 ft to 45 ft (10.67 to 13.72 m), and varied in height from 3 ft to 4 ft (0.914 to 1.22 m), to compensate for the possibility of future breaches.

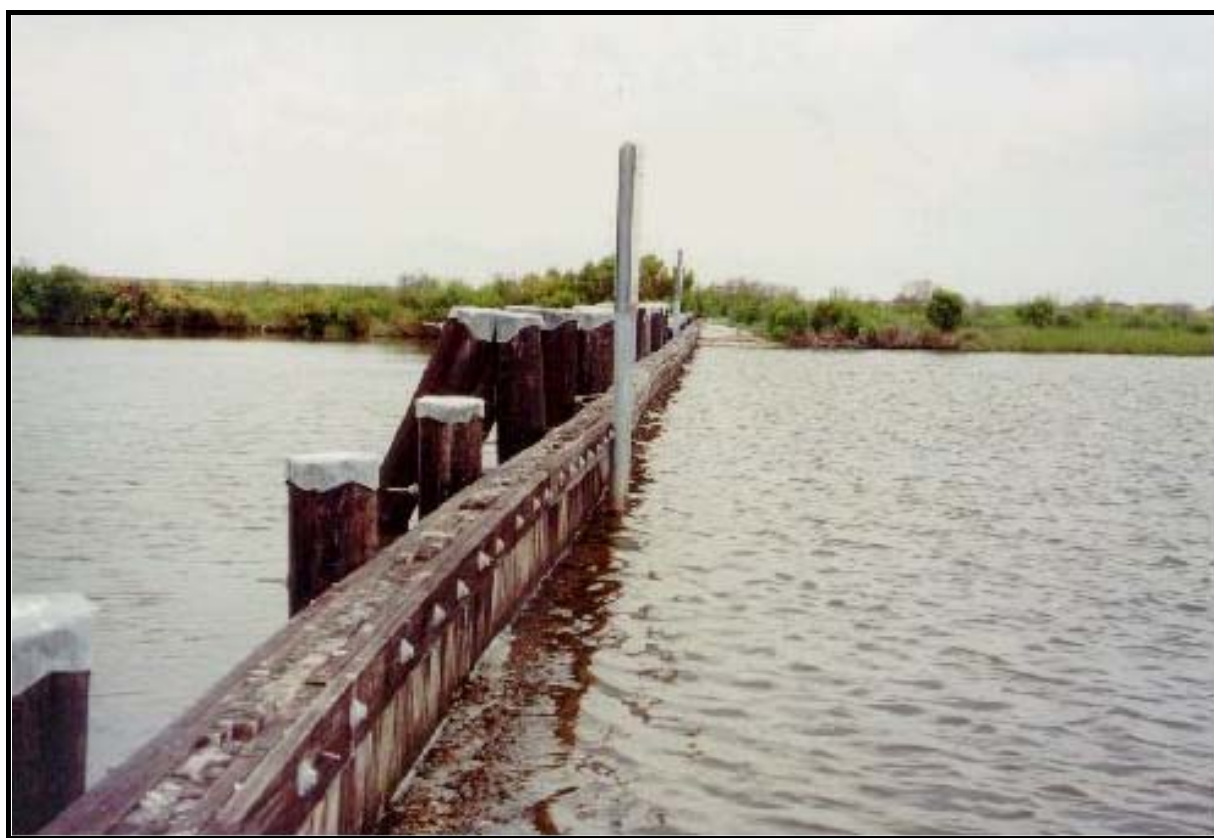
**Figure 4.** Creosote timber plug. One of seven plugs built by LDNR/CRD within the Phase I project area.

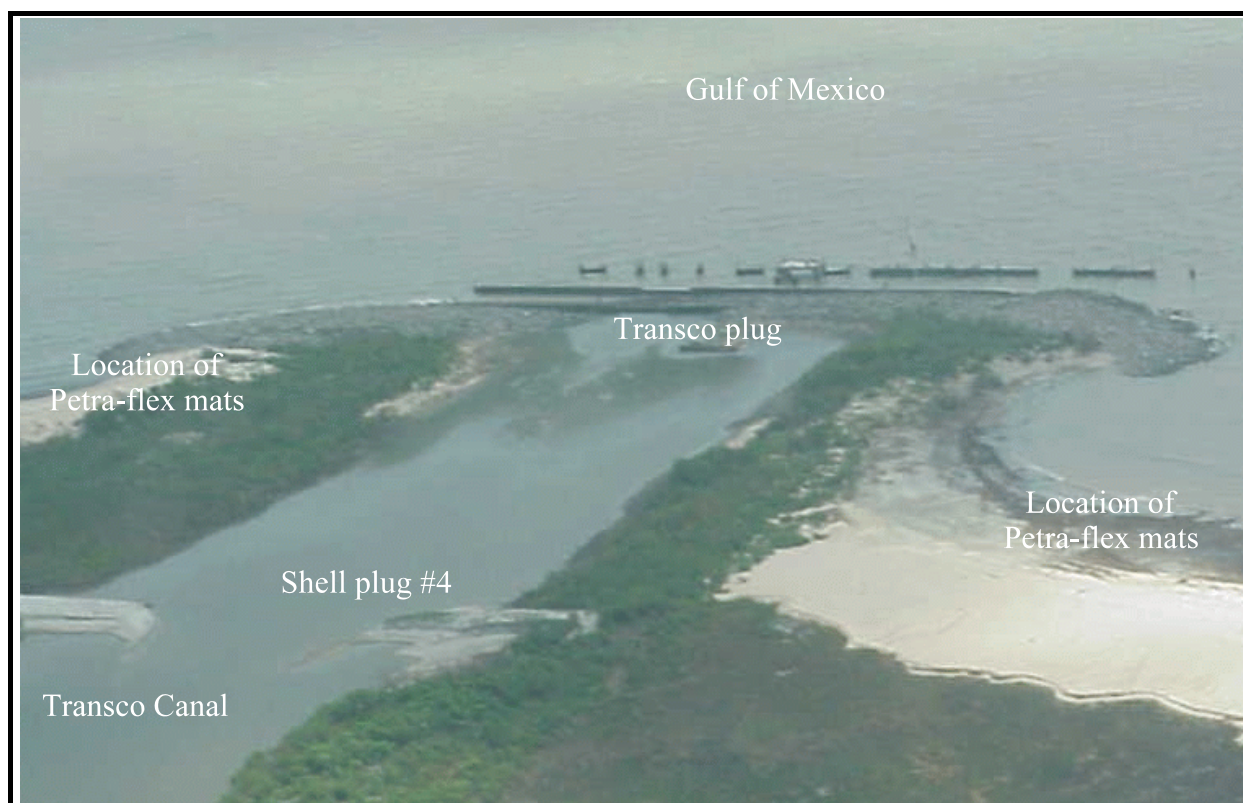
Additionally, due to suspected shoreline erosion on either side of the Transco plug (figure 5), a total of 125 Petraflex<sup>®</sup> articulated concrete mats were added to the southern portion of Phase I during the Phase III construction period. Mats measured 8 ft (2.44 m) wide by 20 ft (6.1 m) long, and were laid perpendicular to the shoreline. Sixty-seven mats were placed west of the plug (536 feet; 163.4 meters) and fifty-eight to the east (464 feet; 141.4 meters).

**Figure 5.** Shell plug #4 after breaching (lower left) with the Transco plug and the Gulf of Mexico in the background. Photo was taken prior to Phase III construction.

Additionally, as mentioned above, the height of the rock in the “breach area” (Phase II) was increased, Petraflex® articulated concrete mats were added near plug #4 (Phase I), and plug #4 was re-built using oyster shell.

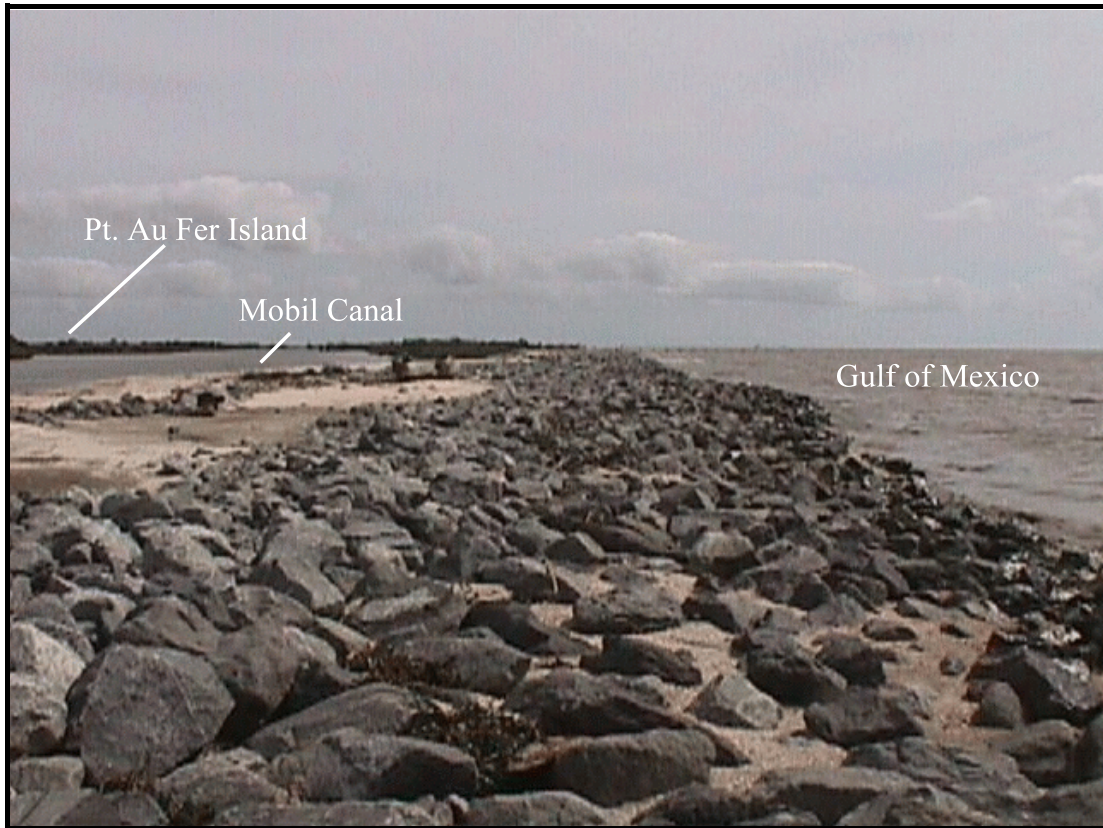
**Figure 6.** Rock wall armoring the shoreline along the southern portion of Phase II, looking east.

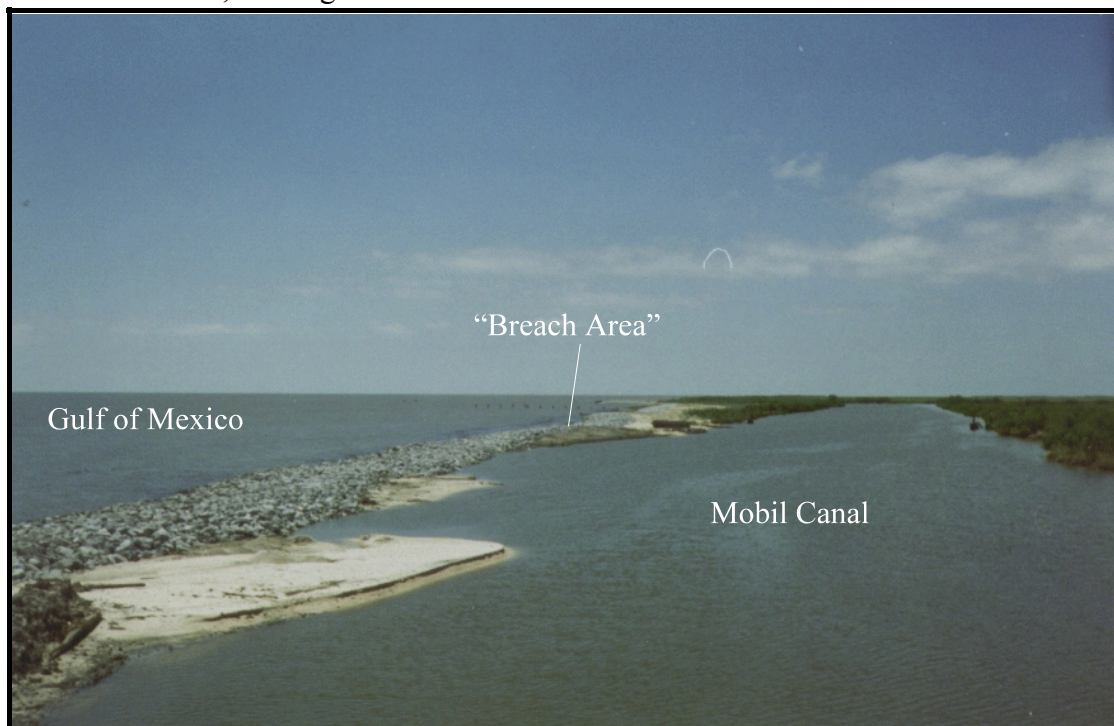
An additional 388 linear ft (118.26 m) of 250 lb. (113.4 kg) class stone was added to Phase II during the Phase III construction period, specifically from May 11 - 12, 2000. The stone was added to the “breach area” to increase the rock armor elevation another 1 ft to 2 ft (0.31 to 0.61 m).

**Figure 7.** The "breach area" following the placement of rock armor (Phase II construction), looking west.
